## FIELD REPORT

### TEST DETAILS

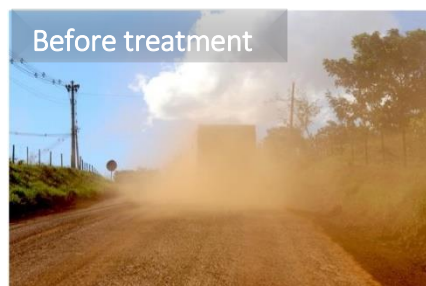
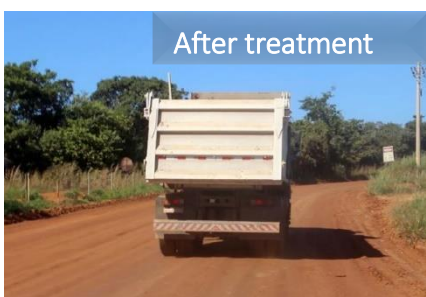
On average, dust emissions decreased by 93% with EA1™

Regarding water consumption, a resulting decrease of 97%, going from spraying water at a rate of 8 liters per square meters every day, to applying, on average, 1.5 liters per square meter each 7 days.

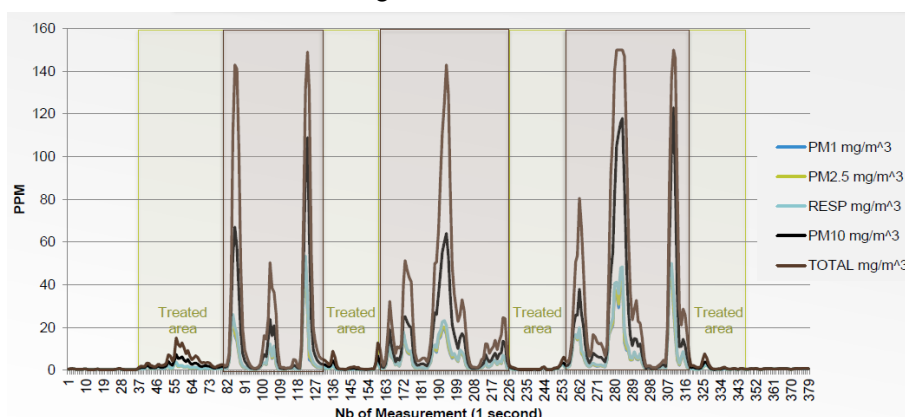
#### Dust monitoring: treated vs. untreated area

**Image1:** Dust was reduced in 95%, going from an average of 32ppm in semi-humid conditions to an average of 1.7 ppm in treated areas.

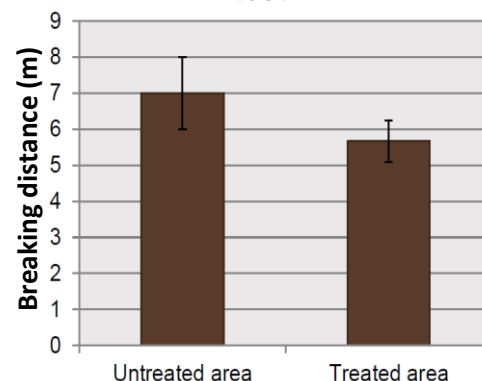
#### Adherence level – Breaking test

**Image 2:** With EA1, the road adherence increased, taking a shorter distance in meters for a truck to come to a full stop.

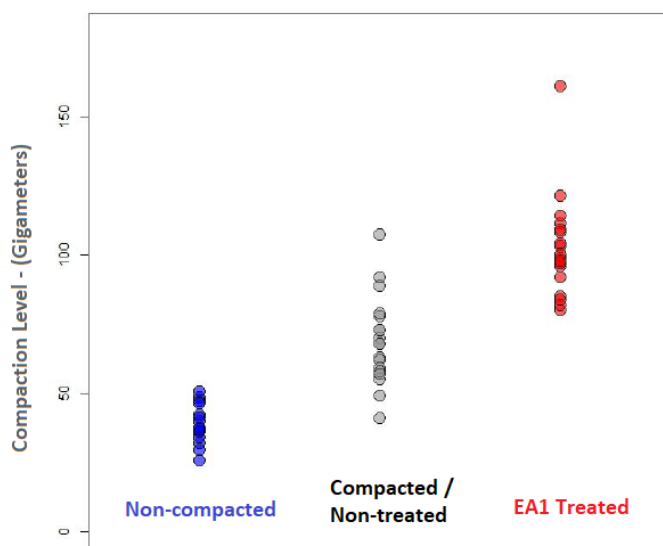
After randomly performing 20 measurements with the Clegg compaction tester on different spots of the basin's surface divided into:

- **Non-compacted area:** zone without any type of treatment
- **Compacted but non-treated area:** zone surrounding the treated area
- **EA1™ Treated area:** zone that received treatment with EA1™

Image 1: Clegg compaction tester results

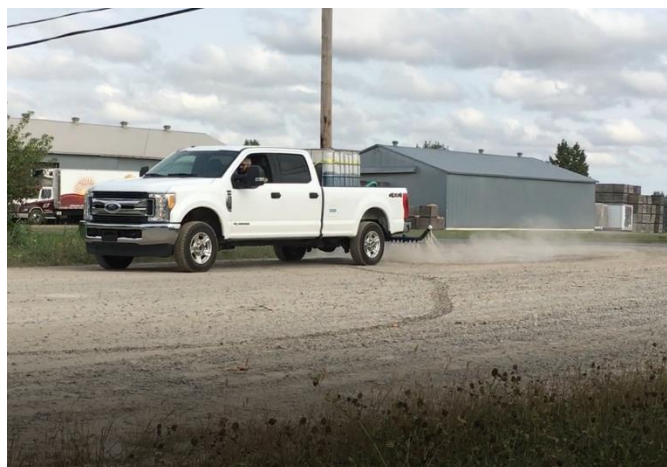
Image 1: EA1 application with pump and spray bar

The product was applied without any soil preparation. A dose of 0.8 L/m<sup>2</sup> was applied directly on the surface (0-3/4 gravel, medium-intensity traffic).

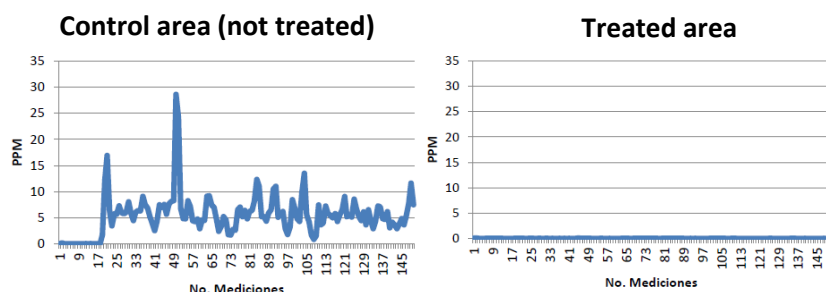
Despite the event that affected the fulfillment of the test, it was possible to obtain a **99% decrease** of dust emissions. Water consumption for dust control decreased from 16 applications per day (24h) to only 2. This represents an **82% reduction** in water use.

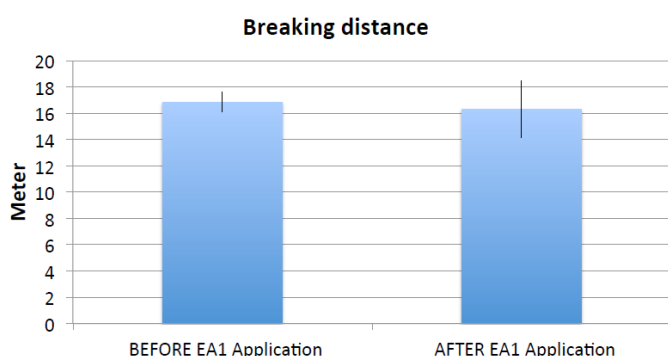
#### Adhesion & Breaking Test

EA1™ does not have any adverse effect on adhesion. Therefore, the road is not slippery and there is no negative impact of using the EA1™ on operational safety.

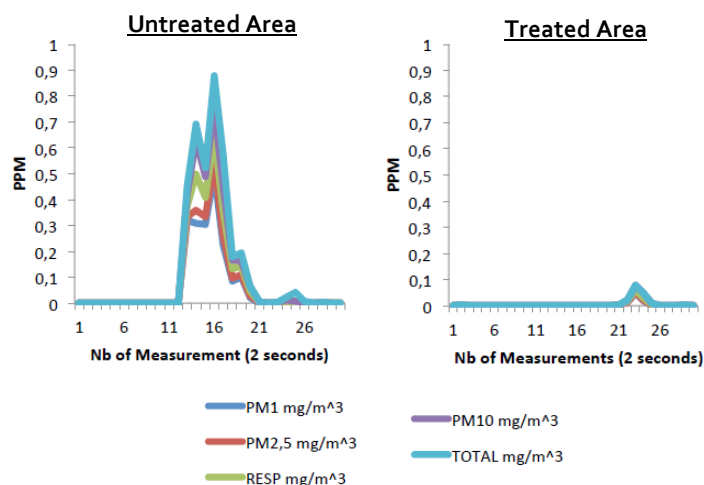
#### Dust Monitoring

The dust emissions on the treated area after EA1™ treatment were on average of 0.027 PPM, which is 96% lower than the average value measured for the untreated area (under wet conditions) of 0.692 PPM.
